The stall of controlled airliners

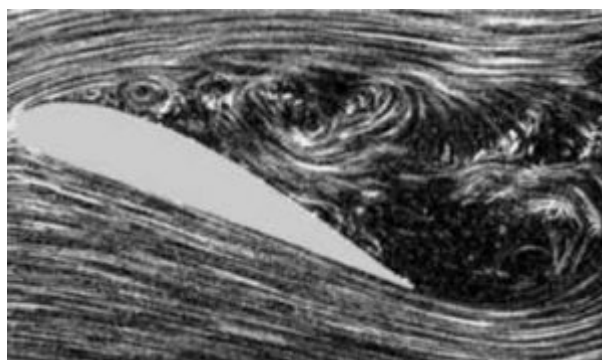
Figure 1. Wind tunnel visualization of the delamination of the boundary layer on the upper surface of a wing with an incidence exceeding a certain threshold [Source: By Jaganath at English Wikipedia][GFDL (<http://www.gnu.org/copyleft/fdl.html>) or CC-BY-SA-3.0 (<http://creativecommons.org/licenses/by-sa/3.0/>)], via Wikimedia Commons]

Most air disasters that have remained in memory, such as Air France Flight 447 from Rio to Paris in June 2009, involve a **stall**. This term refers to a loss of altitude due to a decrease in lift, which is caused by the disbonding of the boundary layer present along the upper surface of the wing, as shown in Figure 1. The aircraft, whose weight has not decreased, then engages in a fall that can only stop if the pilot or autopilot system can correct this loss of lift.

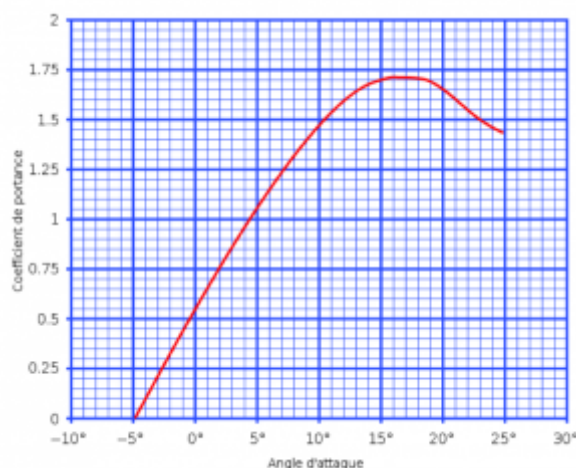
Figure 2. Example of variation of the lift of a wing as a function of its incidence (or angle of attack). The lift of the tested wing varies almost linearly between -5° and $+10^\circ$, then reaches a maximum around 16° before decreasing

Let's see what it's all about first. Since lift is the result of pressure forces on the wing contour, for it to be positive, it is necessary that the air velocity on the upper surface (above the wing) is greater - the pressure lower - than that on the lower surface (below the wing). However, the opposite happens in the event of a well marked separation, since the vortex clearly visible in Figure 1 brings air back to the immediate vicinity of the wall and thus reduces the relative velocity between the wing and the surrounding fluid. This phenomenon, which is not violent but progressive, is linked both to a slowdown of the aircraft, which is already sufficient to explain a reduction in lift, and to an excessively rapid increase in incidence, often controlled by the pilot to compensate for the decrease in speed. The critical value of the incidence leading to the stall depends on the speed and shape of the wing. In general, it is between 5° and 20° ; it is close to 16° in the particular case of Figure 2. Moreover, since this stall is related to the disbonding of the boundary layer, as soon as it appears, the eddies present in the area of the wall that is lifted off generate fairly large pressure fluctuations that shake the aircraft and thus warn the pilot.
